# Renovating a 120-year-old church using modern technology

Perched high above Augusta Street in downtown Staunton, Virginia, St. Francis of Assisi welcomes parishioners and guests from this modest community of 24,000 residents.

### St. Francis of Assisi Church Staunton, VA

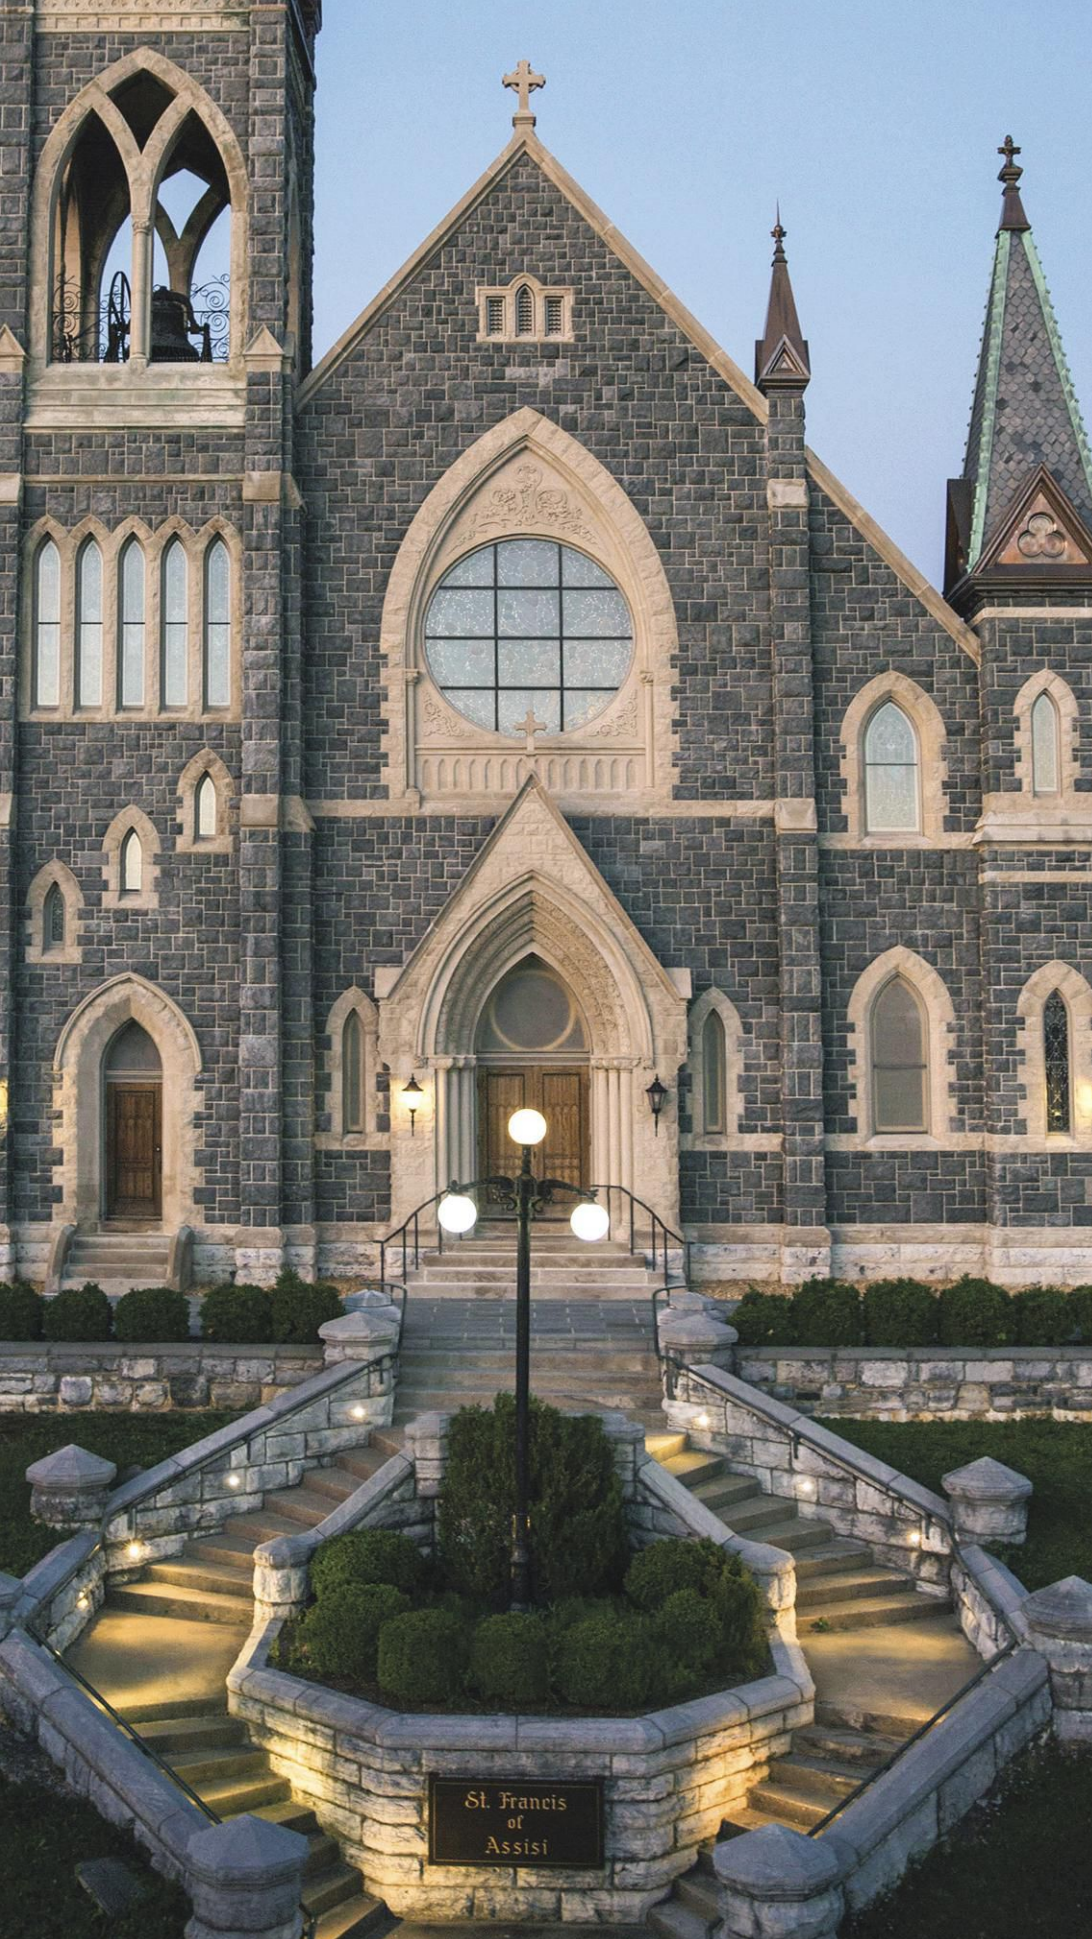
**St. Francis of Assisi is a 120-year-old Gothic-style Roman Catholic church which holds a prominent space in downtown Staunton, Virginia, home to a community of 24,000 residents. Photo courtesy of Tim Hoysradt Photography**

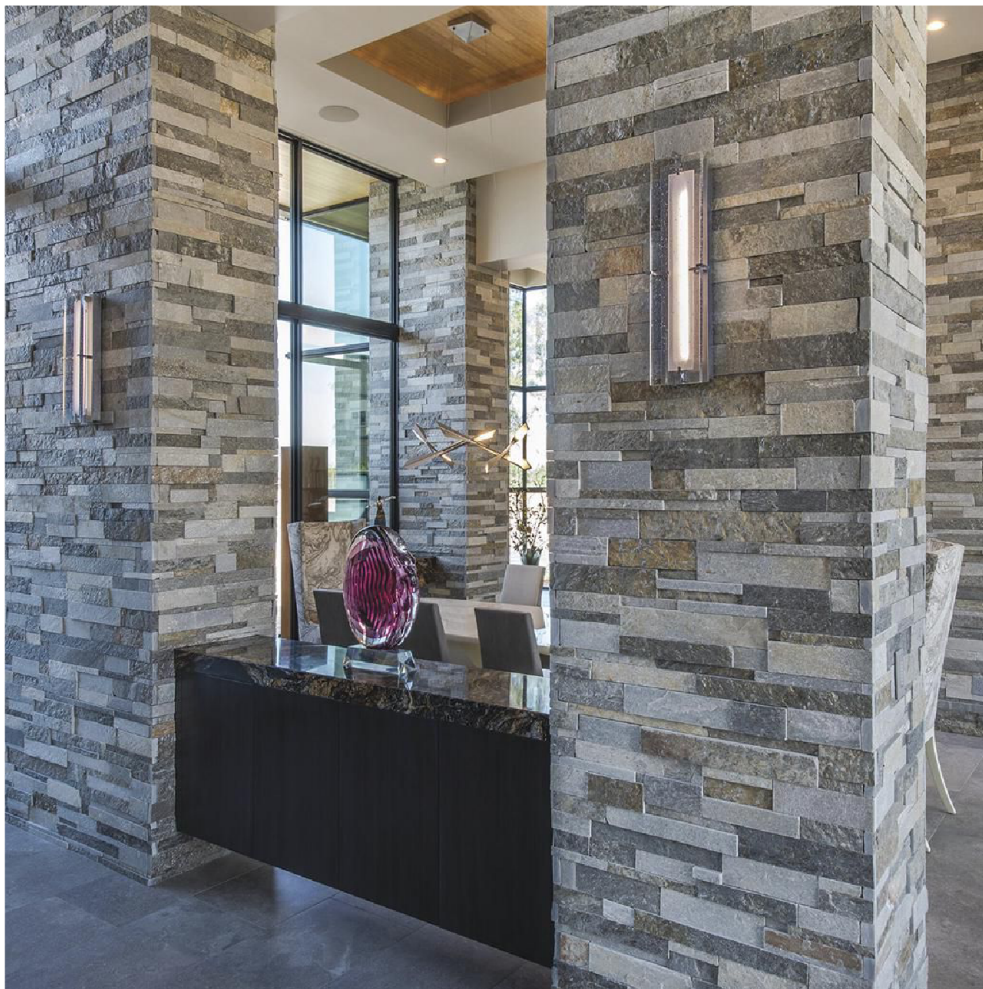
Natural stone is beautiful, durable, sustainable, and easy to maintain. Stone can be used in a wide variety of exterior and interior applications, as seen in this Las Vegas residence. This charcoal and white quartzite stack stone from Northern Stone Supply was supplied by Arizona Stone.

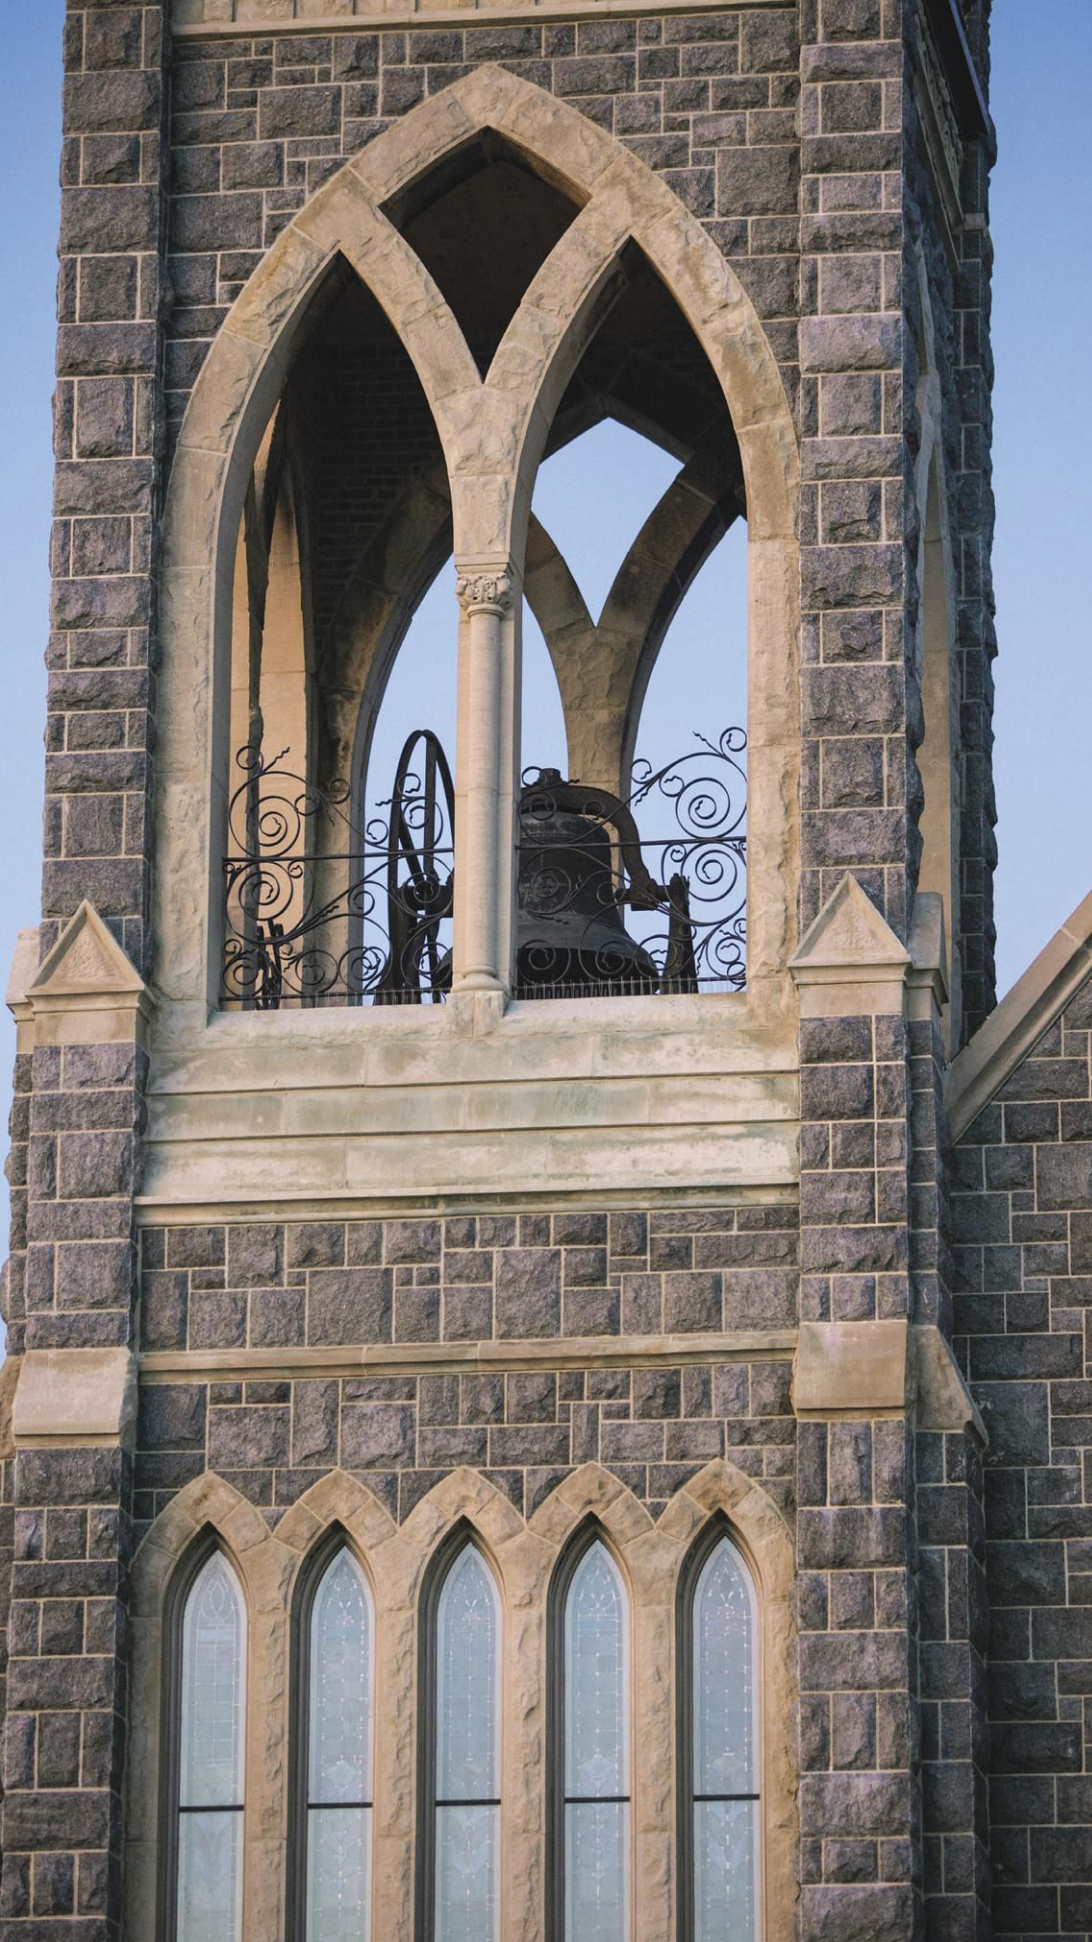
**The parishioners knew they had to replace the serpentine material that was failing, but wanted to match the pattern of the 120-year-old stones while keeping the existing limestone material in place. Photo courtesy of Tim Hoysradt Photography**

Since the limestone was to remain, that required shoring. "Behind the stone, there was an existing brick façade which had to be torn out and replaced as well," added Strand. "The installation process was strategically and systematically sequenced by the engineering firm to ensure there was no harm to the integrity of the building's exterior and interior. For us, it required extra detail on our drawings."

Each piece of stone had a specific stone mark and piece number in an effort to keep tabs on where each stone fit into the picture, noted Strand.

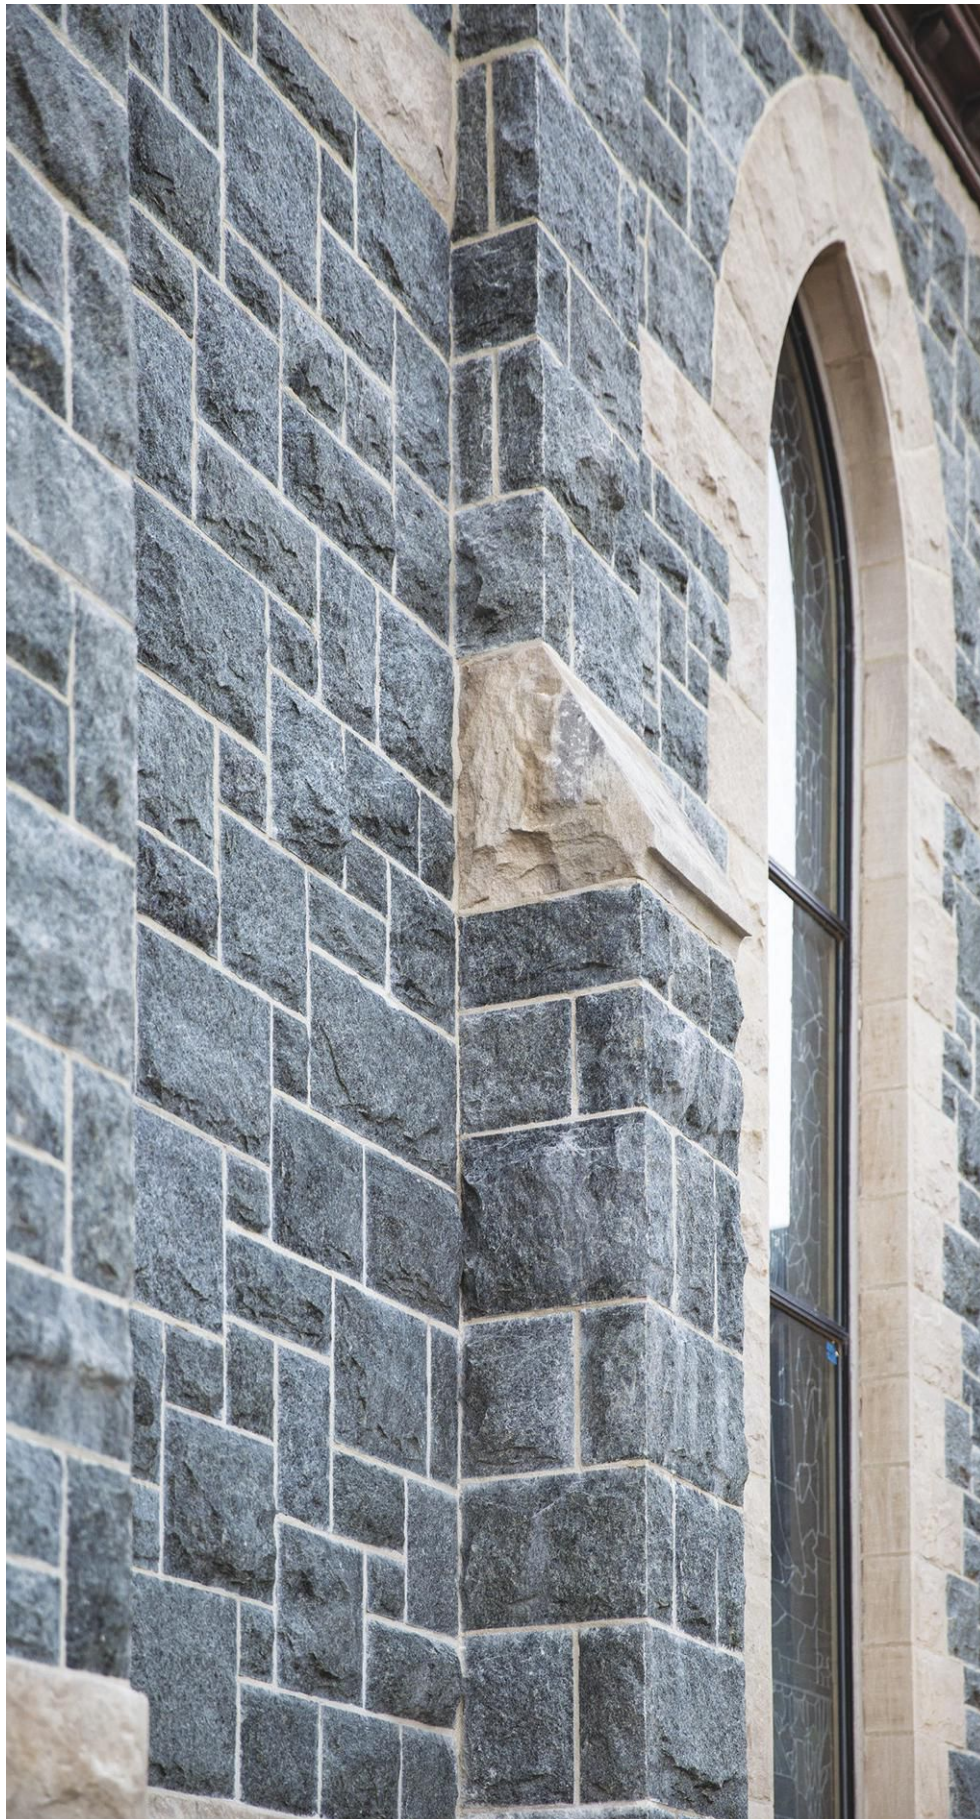
**In total, 6,706 4-inch cubic granite pieces in Mountain Green with a Split finish were produced and installed at St. Francis of Assisi. Photo courtesy of Tim Hoysradt Photography**

In total, 6,706 4-inch cubic granite pieces in Mountain Green with a split finish were produced and installed at St. Francis of Assisi in downtown Staunton, Virginia. The church restoration was completed in May of 2016, and Bishop Francis DiLorenzo celebrated with a mass to commemorate the renovation's completion. The years of planning, fundraising and execution were well worth the wait — St. Francis remains perhaps the most beautiful structure in downtown Staunton, with a heritage preserved for many years to come. ■

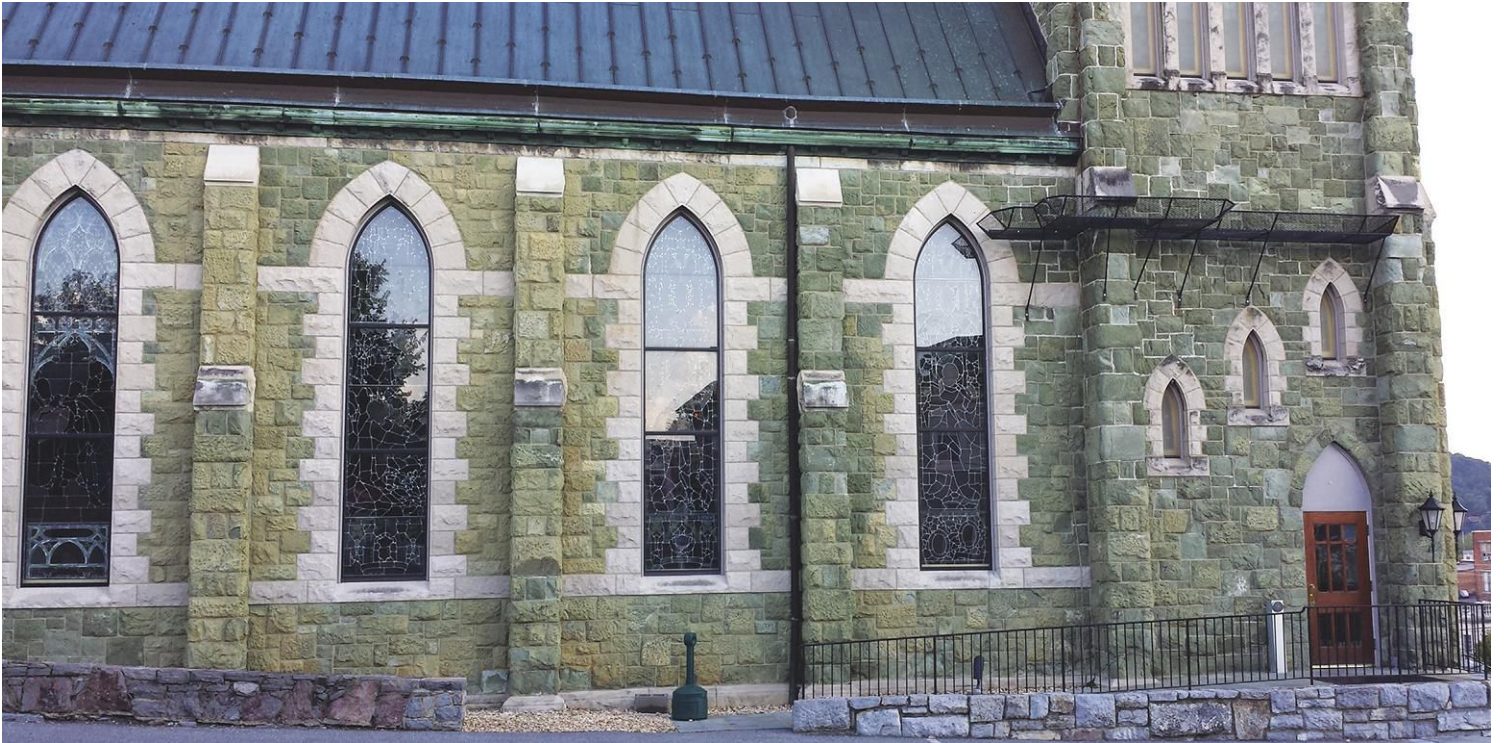
Choosing the right stone wasn't the only thing to consider. Originally built by hand, many of the serpentine pieces were very irregular and joints varied in size. Matching the existing pattern presented another challenge. Photo courtesy of Coldspring

Choosing the right stone wasn’t the only thing to consider. Originally built by hand, many of the serpentine pieces were very irregular and joints varied in size. Matching the existing pattern presented another challenge.

To meet this challenge, photos and field measurements were taken to fully replicate the pieces. Piece size and joint variations were reconciled during the drafting process.

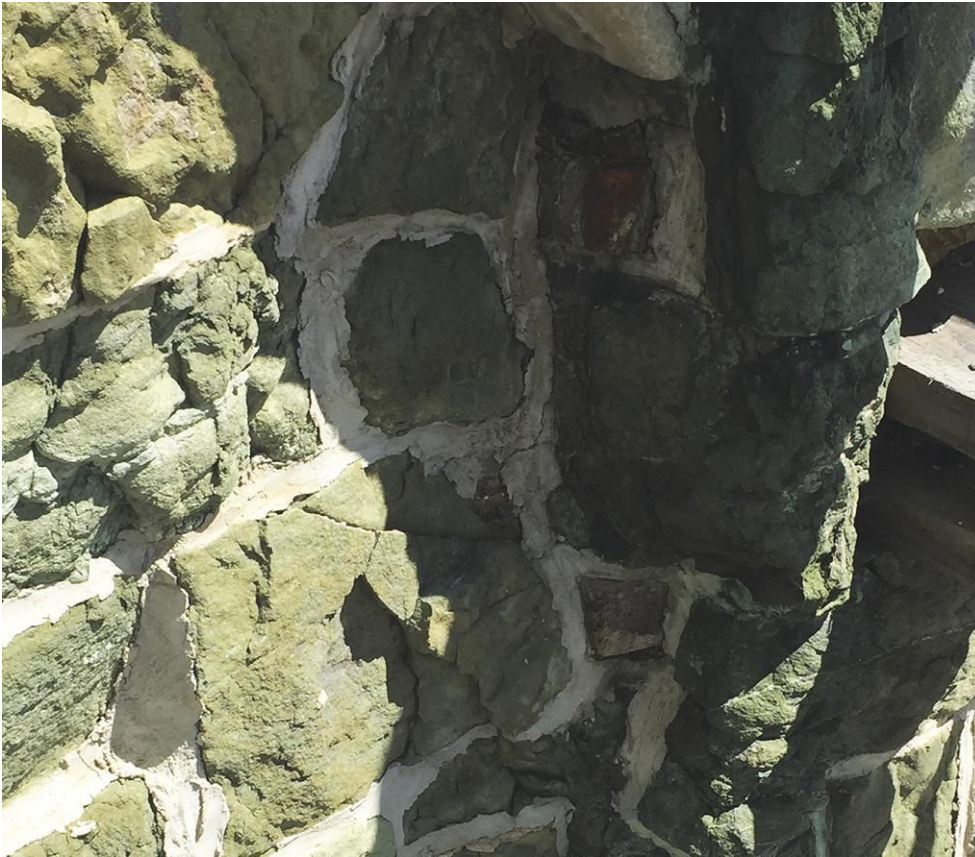
To pay tribute to the parish's Irish heritage, the original builders selected green serpentine for its exterior but that decision would prove to be an issue 100 years later when the existing serpentine had deteriorated and safety had become a concern. Photo courtesy of Coldspring

would become an issue more than 100 years later when the existing serpentine had deteriorated to such an extent that safety had become a concern.

To temporarily halt the hemorrhaging, catch-guards were put into place in certain areas around the entire facade of the church to trap the material

that was spalling and falling off of the building. The parishioners knew they had to replace the serpentine material that was failing, but wanted to match the pattern of the 120-year-old stones while keeping the existing limestone material in place.

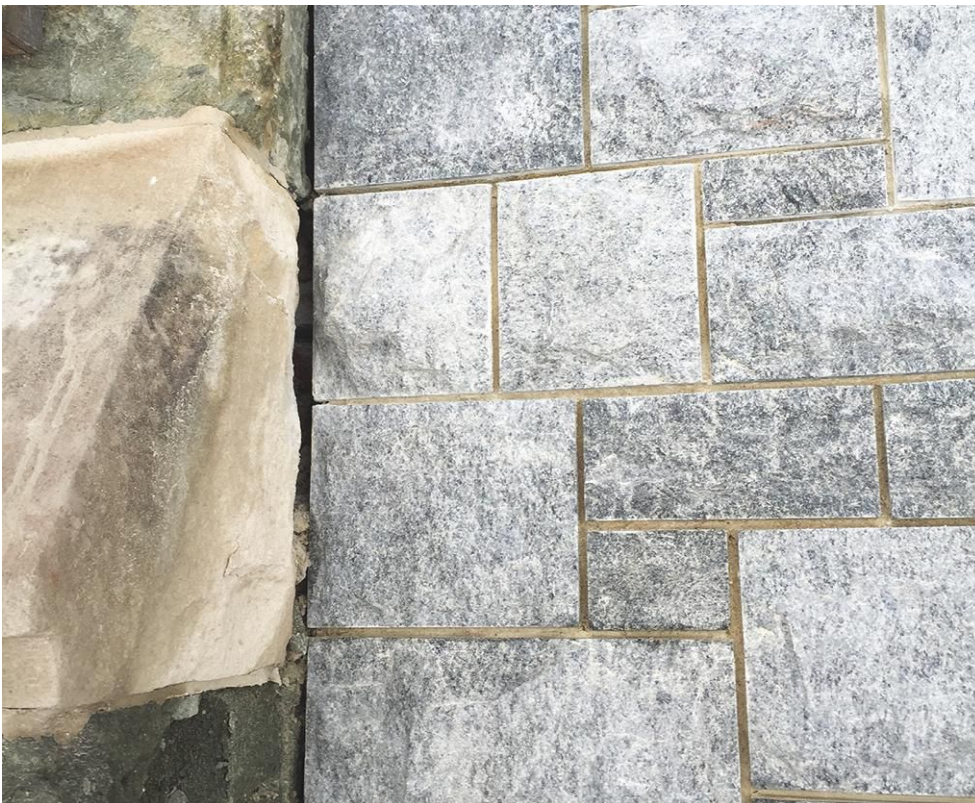
To help with the placement, each piece of stone had a specific stonemark and piece number so once the stones were ready to be placed, it would be easier to determine where each stone belonged. Photo courtesy of Coldspring

"For example, 'A-1' told you that the piece belonged in bay A, and piece 1 was labeled on the drawing for ease of installation," she explained. "Ultimately
